Manhole Inspection Summary

Manhole # S23K1_003MH

Insp Date: **11/25/08 1:06 PM**

Location Address: **2913 Mallview Rd.**

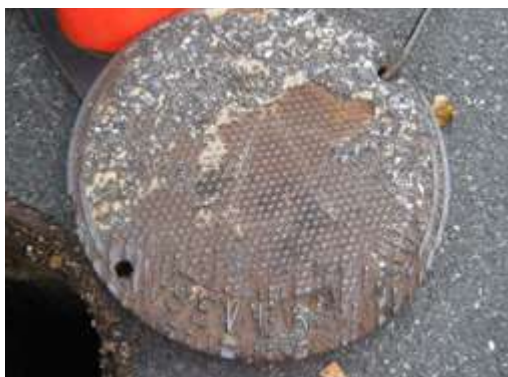
Condition: **Worn**

worn lid

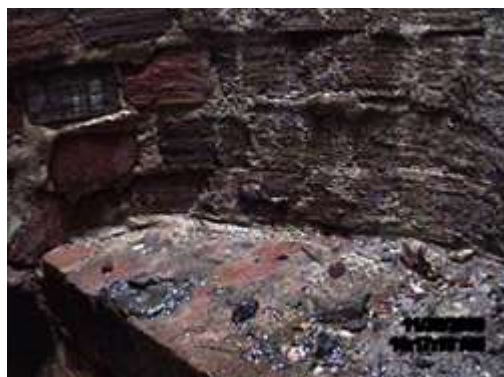
Defect 4

Infiltration: ☐ None ☐ Joint ☒ **Cracks** ☐ Mortar ☐ Roots ☒ **Wall**

barrel infiltration / debris on bench

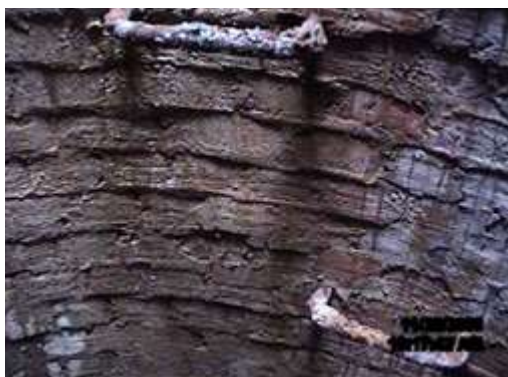
Defect 3

Count: **6** Missing: **0** ☒ **Corroded**

corroded steps

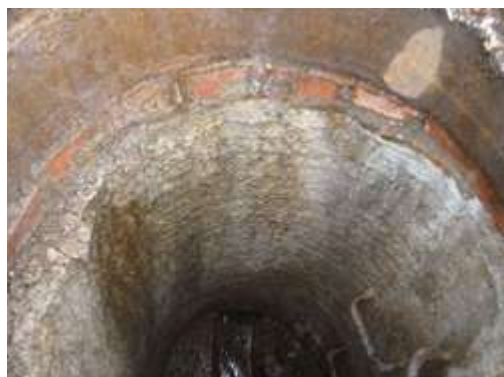
Defect 2

Infiltration: ☐ None ☐ Joint ☐ Cracks ☒ **Mortar** ☐ Roots ☐ Wall

Infiltration: ☐ None ☒ **Joint** ☐ Cracks ☐ Mortar ☐ Roots ☒ **Wall**

chimney and corbel infiltration and
mineral build-up on corbel wall

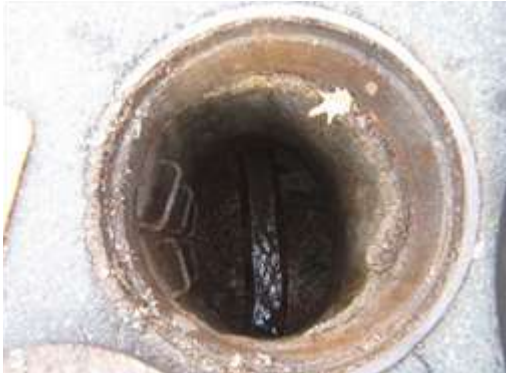
Defect 1

Offset: **2** (in.)

☒ **Leaks**

frame offset & leaks

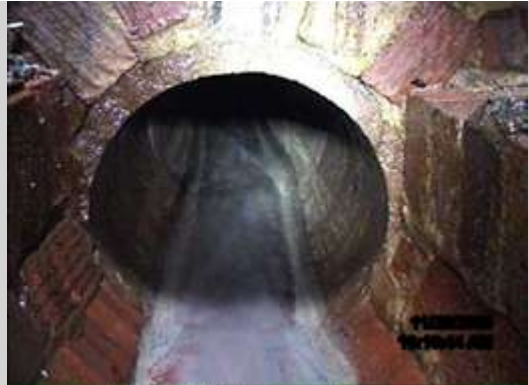
12 O'Clock Outflow

10 in. Circular Gravity Sewer
Pipe Out @ 12 O'Clock

Pipe Height: **10.8** (in.) Rod and Bar (Angled)
Pipe Material: **Clay** ☐ Pipe Lined
Invert Depth: **10.91** (ft.) Flow Characteristics: **Slow**
Deposits: ☒ None ☐ Mud ☐ Sludge ☐ Debris ☐ Grease
Silt Depth: **0** (in.) Deposits Extent:
Infiltration: **None** Pipe Seal Cond: **Sound**

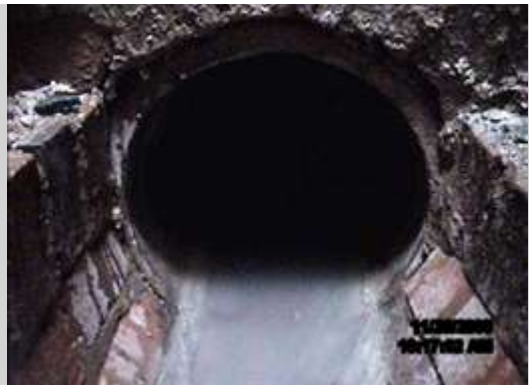
7 O'Clock Inflow

10 in. Circular Gravity Sewer
Pipe In @ 7 O'Clock

Pipe Height: **10.8** (in.) Rod and Bar (Angled)
Pipe Material: **Clay** ☐ Pipe Lined
Invert Depth: **10.60** (ft.) Flow Characteristics: **Slow**
Deposits: ☒ None ☐ Mud ☐ Sludge ☐ Debris ☐ Grease
Silt Depth: **0** (in.) Deposits Extent:
Infiltration: **None** Pipe Seal Cond: **Sound**
